██████ Mitigation Services

Type of Loss
Water

Water damage

Initial Inspection 4-13-2022 BT

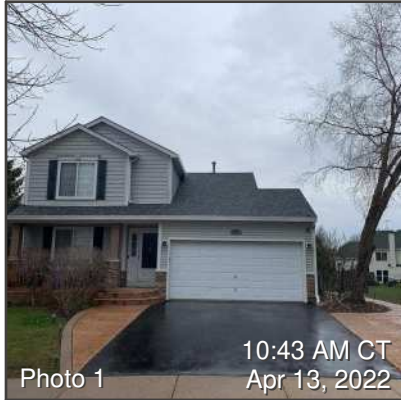
OVERVIEW PHOTOS: Risk

This is a single-family home with water damage to the kitchen, dining room, and basement. The source of the loss was a damaged plastic water supply line behind the refrigerator. The source has been corrected. [REDACTED] has been hired for mitigation services.

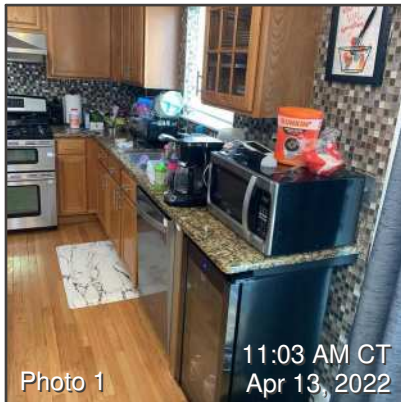
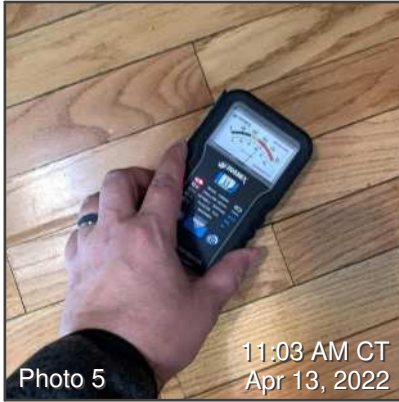
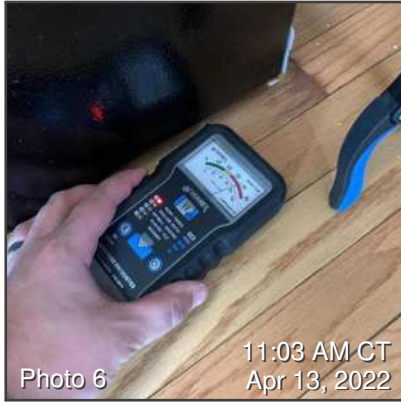
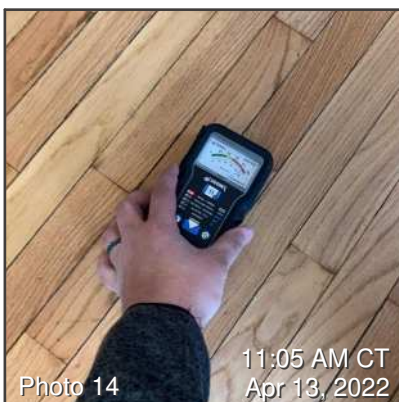
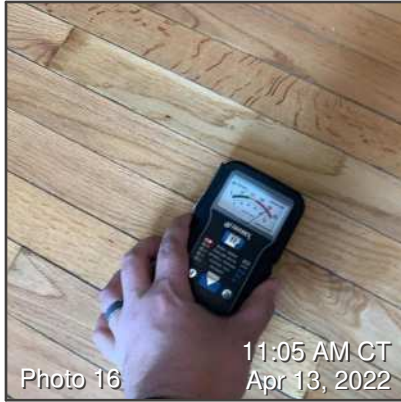
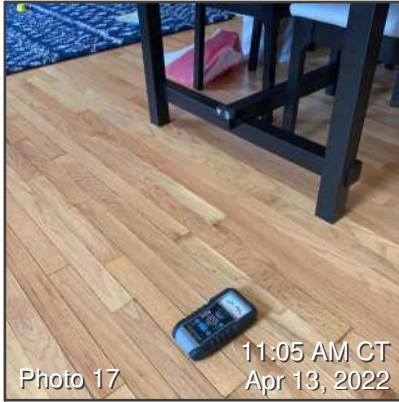
OVERVIEW PHOTOS: Kitchen

Water migrated from the plastic supply line out into the kitchen area for an unknown amount of time. The drywall wall behind the refrigerator and next to the pantry will need to have the base trim removed and walls ventilated to promote proper drying. The toe kick next to the fridge will need to be removed to examine the flooring beneath. The hardwood flooring is extremely cupped and will need to be cut and removed. Once the hardwood flooring is removed we will detail clean and apply a plant-based antimicrobial to the wooden subfloor/install drying equipment.

Detach base trim on impacted drywall (Kitchen)

Inspect the drywall walls for discoloration

If discoloration is not present we will ventilate the drywall walls.

If discoloration is present we will cut the walls to the standard 2 feet

Detail clean and apply plant-based antimicrobial to all impacted surfaces

Install drying equipment and monitor daily

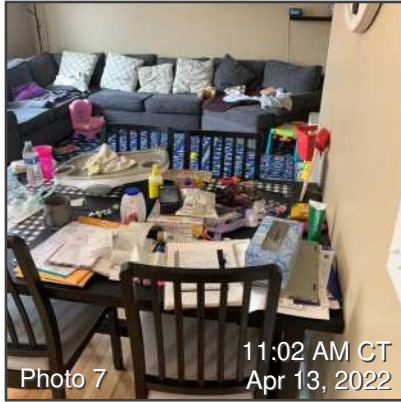
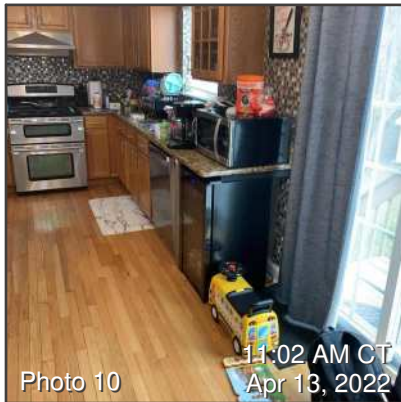
OVERVIEW PHOTOS: Hardwood Floors

Received a call for a new water loss. Refrigerator leak on the kitchen floor. Floors are cupping.

Remove impacted hardwood flooring (severely cupped)

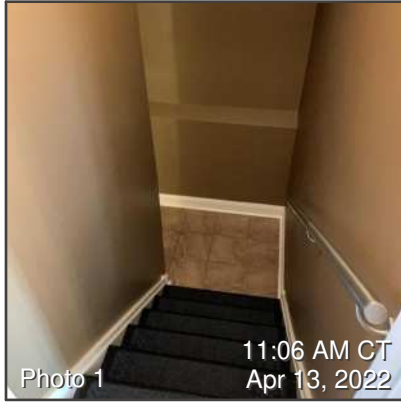
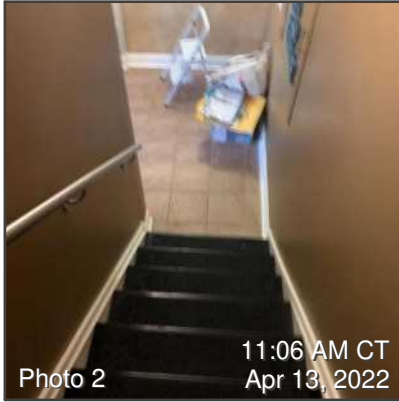
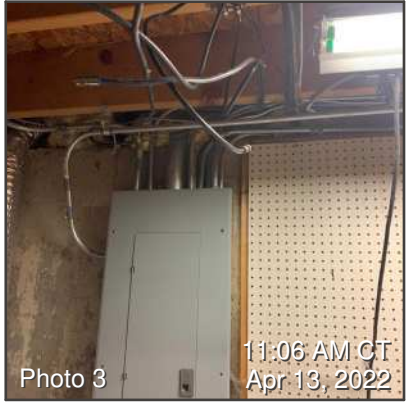
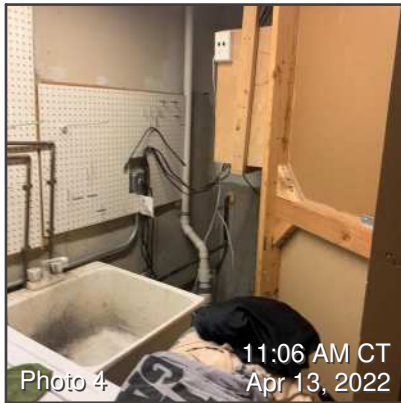
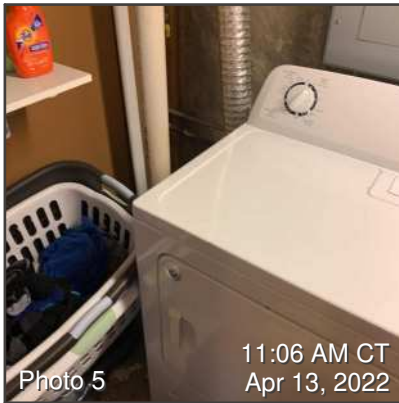
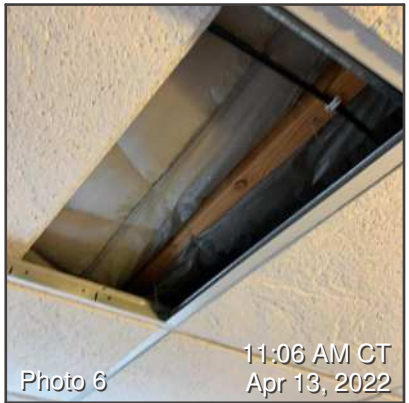
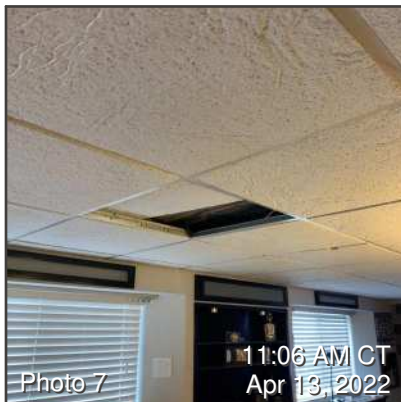
OVERVIEW PHOTOS: Basement

Water continue to migrate through the floor down into the basement. The homeowner noticed water droplets exiting the supply line hole in the laundry room. We will need to further analyze the drop ceiling as the cavity above is completely insulated. We will systematically remove insulation to determine how far the moisture traveled in the ceiling cavity. Once all removals have taken place we will detail clean and apply plant-based antimicrobial.

Remove and save drop ceiling tiles(basement)

Remove and examine the insulation installed in the ceiling cavity (basement)
